OTR Adopt
1219 Sycamore Street
Cincinnati, OH 45202

Attn: Brenden Regan
Re: 1007 Dayton St.
Project No. 17806.04

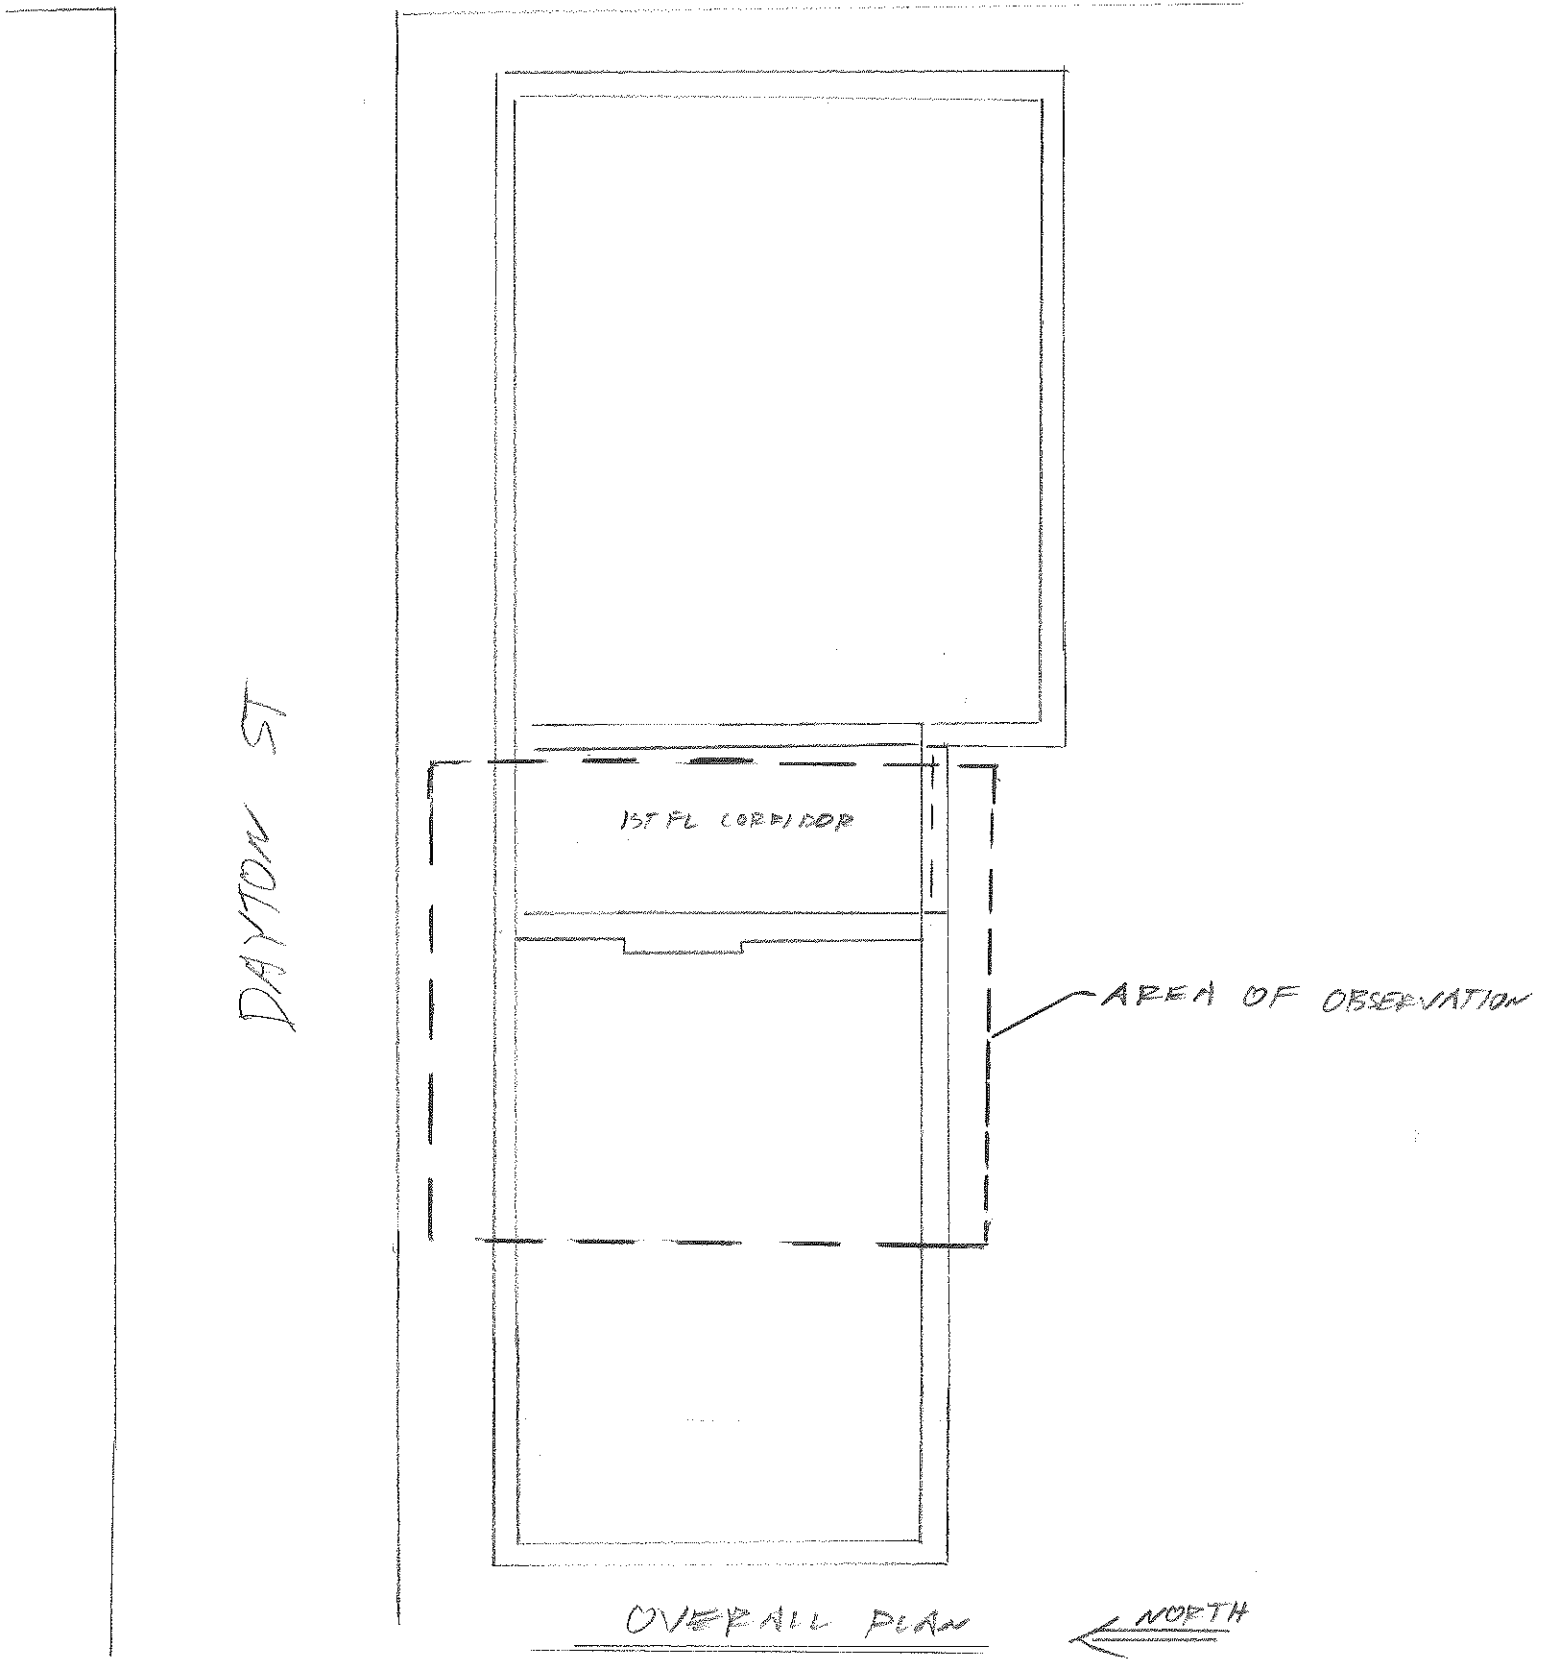
I was directed to look specifically at the structure in the area that is indicated in the attached "Overall Plan." In this area, there was very obvious failure of the exterior and interior masonry walls as well as floors.

- At wall 1 and as needed. Rebuilding masonry walls shall consist of a solid 4" CMU interior wythe and an exterior brick wythe using existing bricks that are not deteriorated, or bricks with similar appearance and composition to the existing masonry. Provide horizontal galvanized 9 gage ladder reinforcement at 8" on center vertically.

- At wall 2 and as needed. When repairing masonry that requires significant replacement of one wythe. The new rebuilt masonry wythe shall be tied to the existing wythe with Spira-lock, by Hohmann & Barnard, at 16" o.c. vertical and 24" o.c. horizontal.

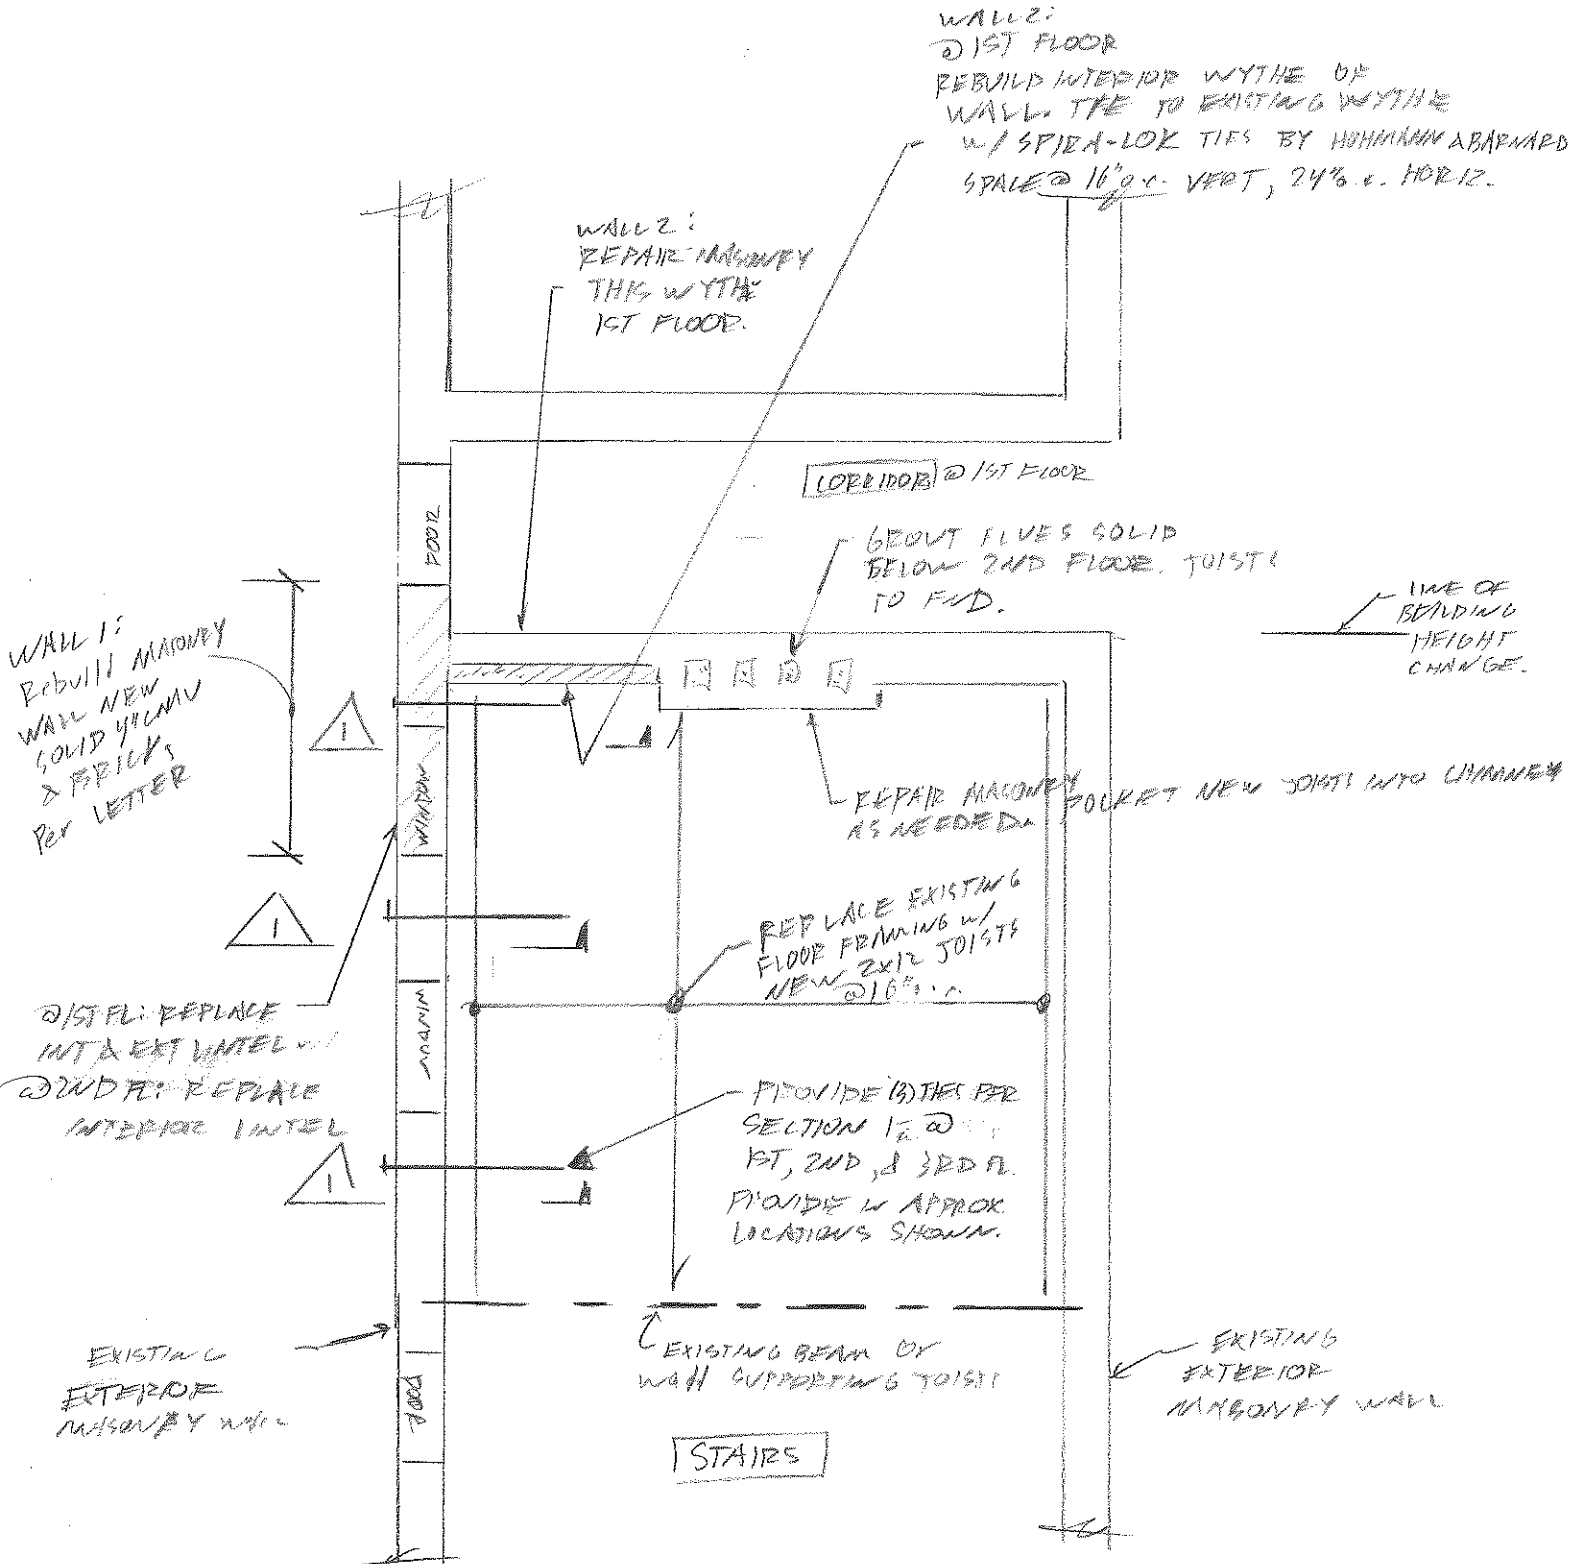
1ST & 2ND FLOOR FRAMING PLANS

Per my observations, the exterior masonry and interior masonry walls in the areas indicated on the attached plans have failed. The 1st and 2nd floor framing is extremely deteriorated/rotted as well as the existing floor sheathing. The 3rd floor/attic framing was not observable at the time of my visit due to finishes and access, but it is likely that this floor is severely deteriorated similar to the 1st and 2nd floor.

- New floor joists and rafters shall be No 1 Southern Pine. Bear all new framing directly on existing or re-built masonry walls, providing joists pockets as needed. Replace all 1st and 2nd floor framing in this area. Replace 3rd floor/attic framing that is deteriorated, remove finishes and expect each joist for deterioration.

- Replace floor sheathing and roof sheathing where deteriorated.

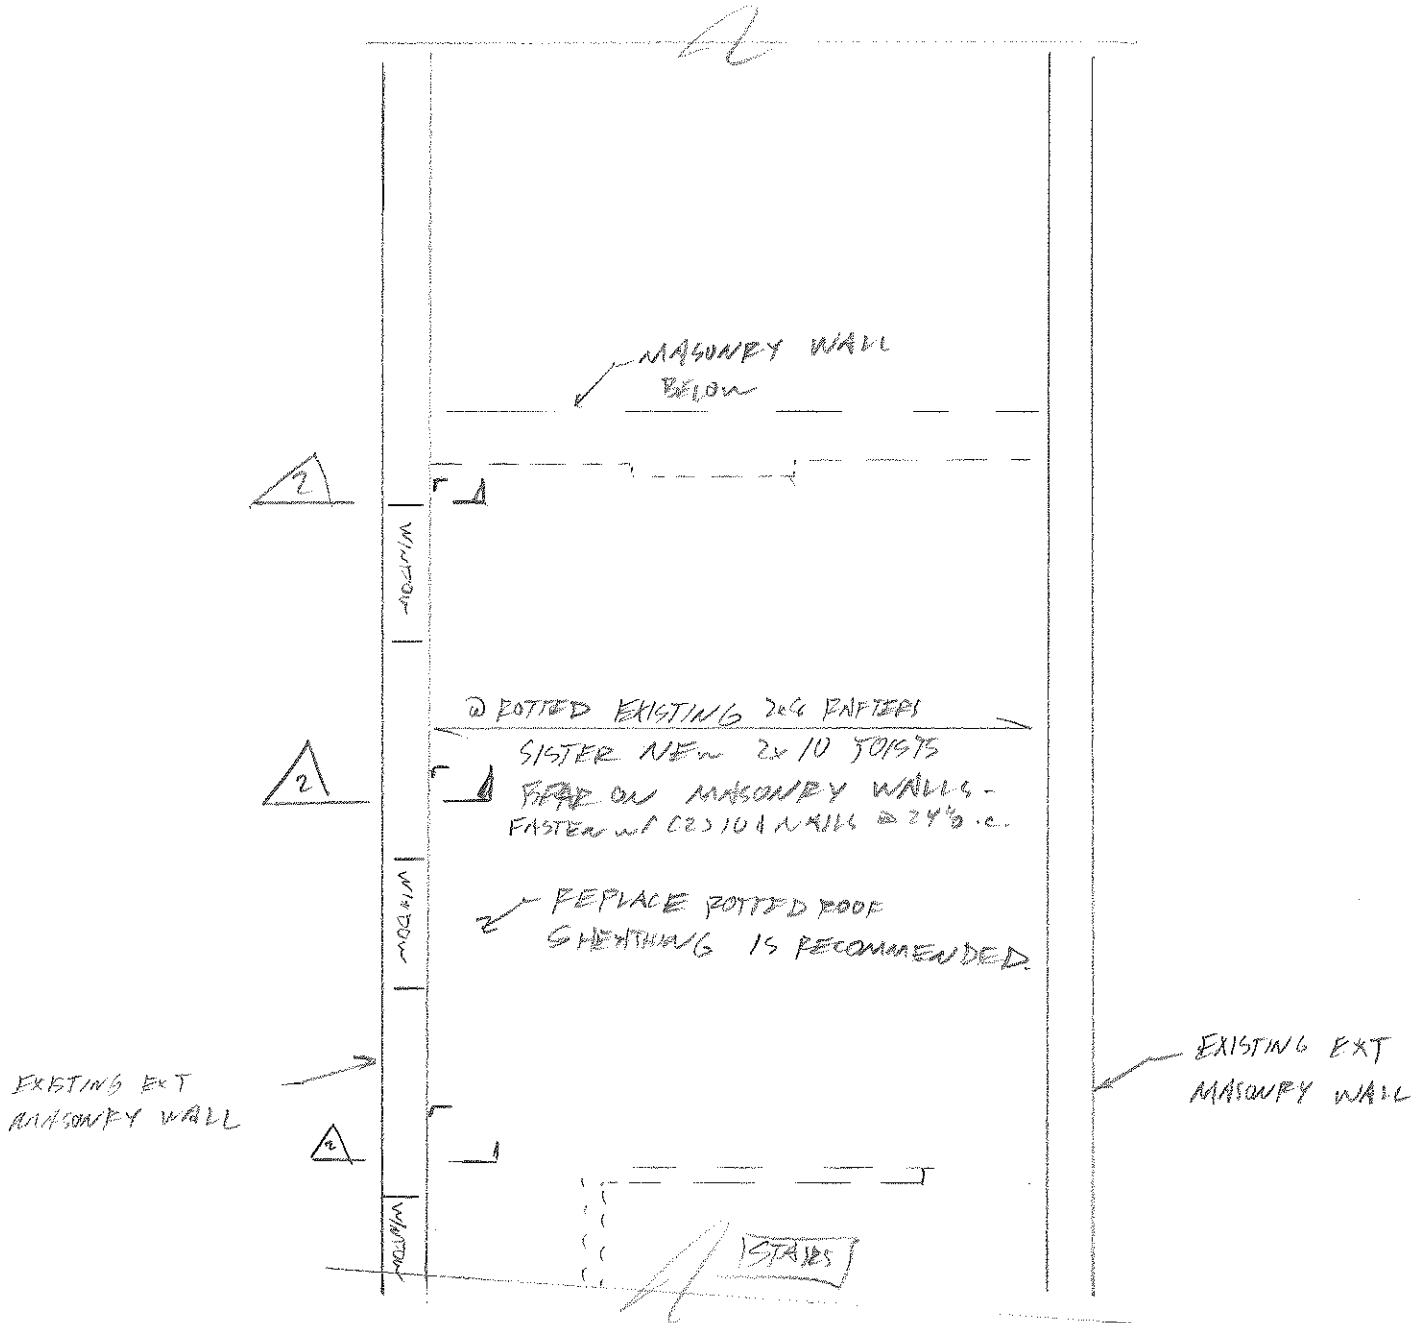
ROOF FRAMING

I was able to observe a small portion of the existing roof framing. Much of the roof framing was covered with plaster. The area that was observed is located directly above the deteriorated floors mentioned previously in this report. In this area, I observed that the existing rafters and portions of the existing roof sheathing were deteriorated.

NOTE: 3RD FL / ATTIC FRAMING WAS NOT VISIBLE, BUT IS LIKELY DEGRADATED. REPAIR FRAMING & SHEATHING AS NEEDED
